# Big Spring Creek Watershed Water Quality Restoration Plan and Total Maximum Daily Loads

**Public Review Draft**  
December 2004

Montana Department of Environmental Quality  
Water Quality Planning Bureau

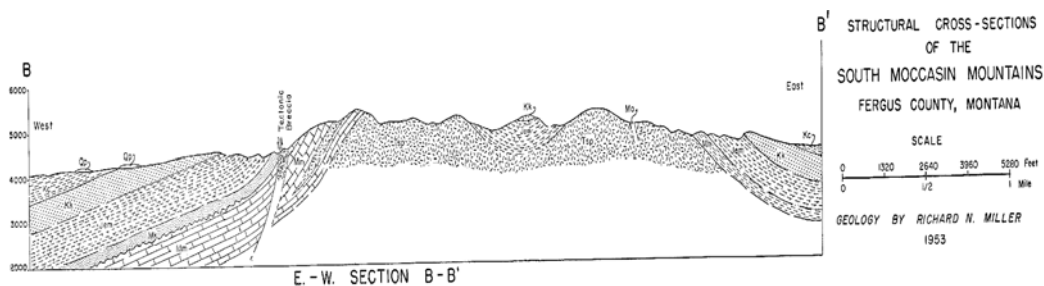
**Figure 2-2. Structural Cross-Section of the South Moccasin Mountains (Miller, 1959).**

The South Moccasin and Judith Mountains bound the Big Spring Watershed to the north and northeast. These mountains are structurally and lithologically distinct from the Big Snowy Mountains to the south, and were formed in Tertiary time when igneous intrusions domed existing sedimentary strata, forming a suite of gumdrop-shaped ‘blisters’ on the plains of central Montana. Subsequent erosion has exposed the porphyritic igneous cores of many of these domes. The intrusive igneous cores of the South Moccasin and Judith Mountains are flanked by Paleozoic and Mesozoic strata that dip, generally, from 20 to 60 degrees, yet some areas exhibit nearly vertical to overturned bedding (Figure 2-2). The dip of these units gradually decreases away from the mountains until, after a few miles, they are nearly horizontal (Feltis, 1973).

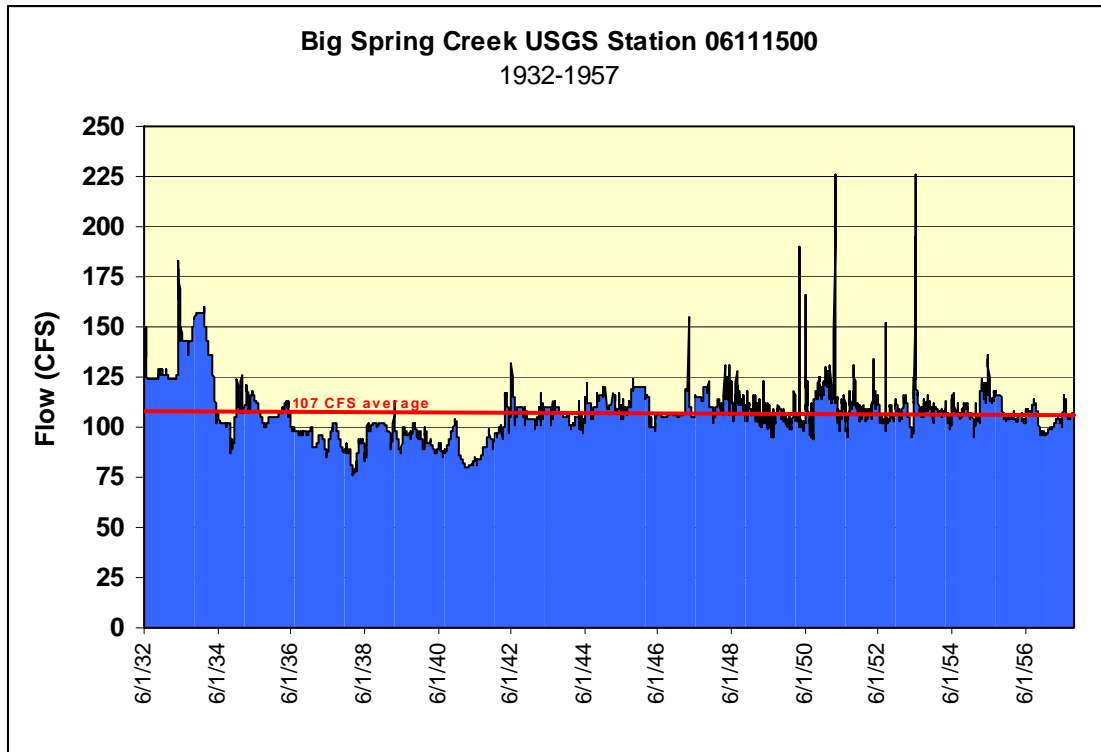
**Figure 2-9. Daily Mean Stream Flow for USGS Station 06111500 from 6/1/1932 to 9/30/1957.**

Feltis (1973) noted that, “discharge from the spring has gradually increased from about 109 cfs in February 1967 to 132 cfs in January 1969. This increase probably reflects the above-average precipitation during 1967 and 1968 following below-average precipitation in 1966.”

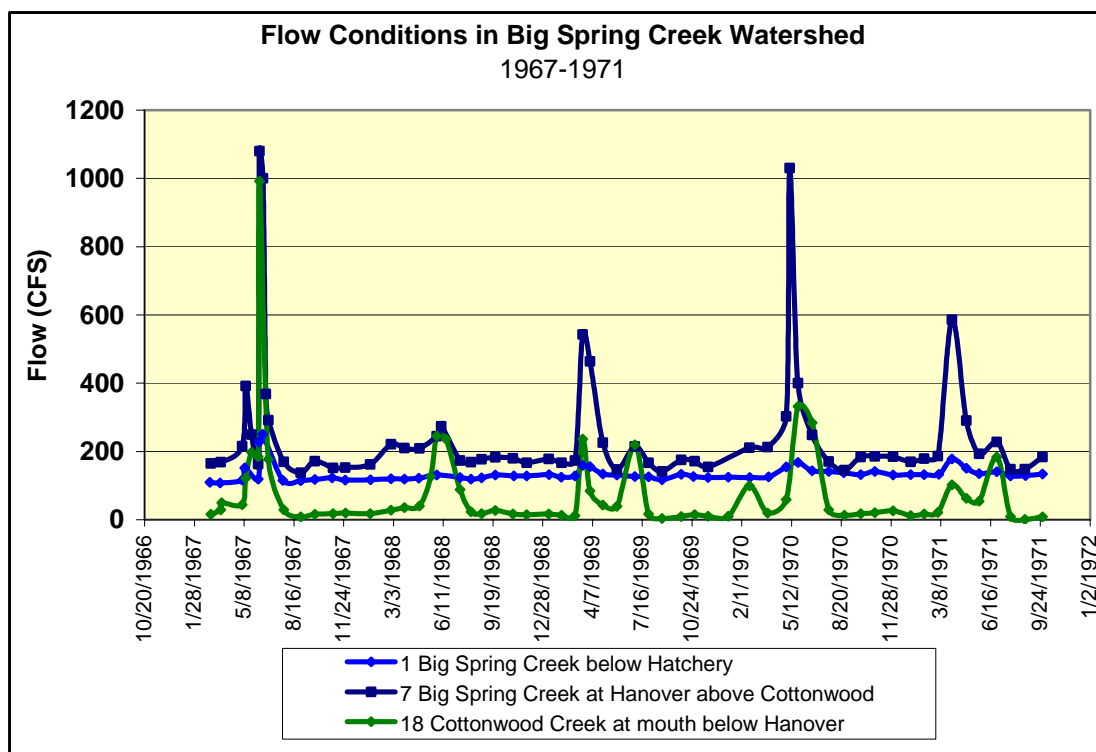
**Figure 2-10. Big Spring Creek Monthly Flow, 1967-1971.**

Below Lewistown, lower Big Spring Creek receives significant spring runoff input from Cottonwood Creek. While recorded discharge measurements on lower Big Spring Creek are limited, discharge at stations on Big Spring Creek recorded monthly from 1967-1971 (Figure 2-10) characterize the range of flow conditions typical of the lower watershed. Maximum and minimum recorded flows on Big Spring Creek at Hanover above Cottonwood Creek are 1,080 cfs on 6/8/1967 and 106 cfs on 8/25/1988, however, given the paucity of flow data on the lower watershed, these values should not be taken as true max and min values.

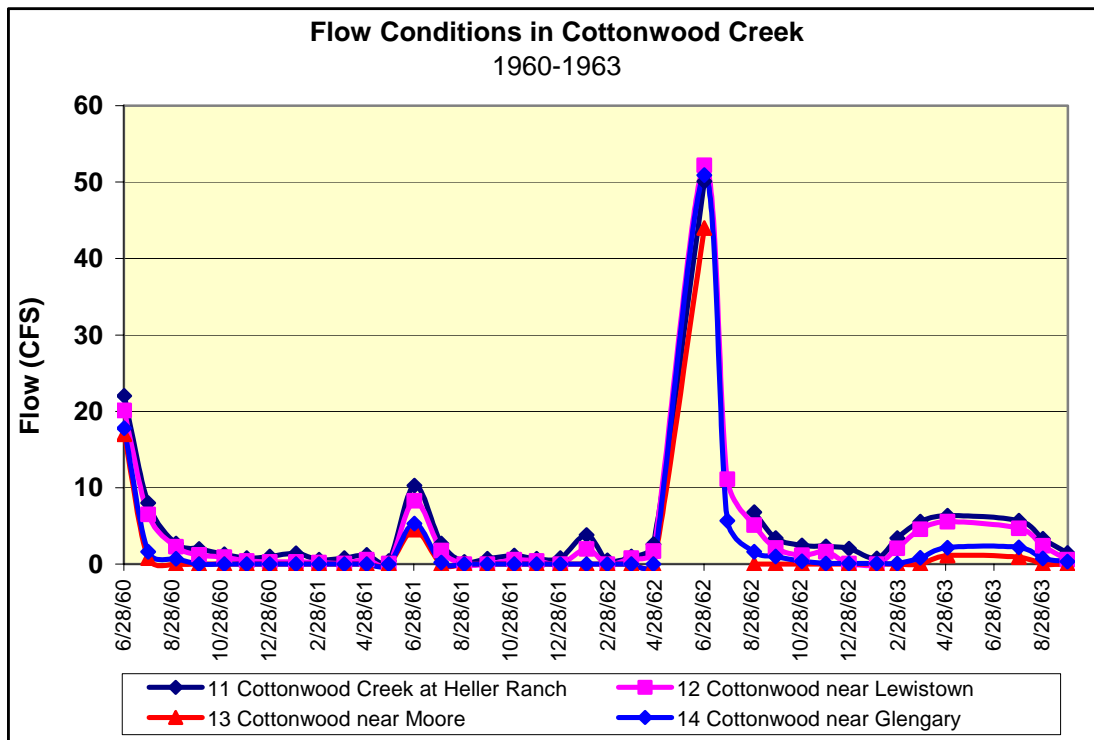
**Figure 2-12. Monthly Flow Data for Four Locations on Cottonwood Creek.**

Available data, as well as personal accounts from residents and landowners, demonstrate that middle Cottonwood, from above the foothill/basin boundary to near Glengary, is susceptible to regular dewatering and severe low flows in all times but snowmelt runoff and storm events. This is likely due to a combination of factors including: natural geology (infiltration into terrace gravels, loss of streamflow to the cavernous Madison limestone), drought and irrigation withdrawals.

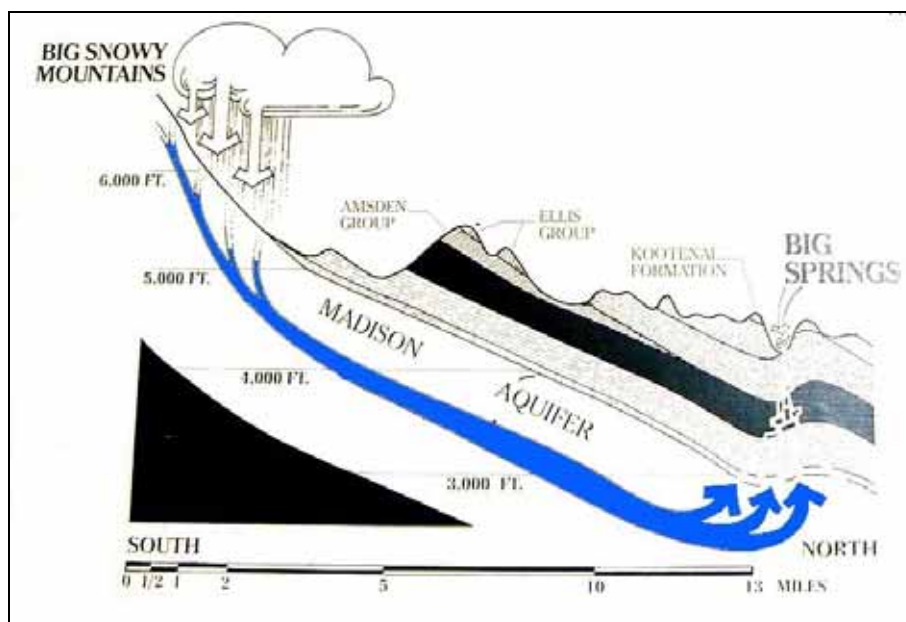
**Figure 2-13. Generalized Cross Section of Water Flow Through the Madison Aquifer.**

Artesian conditions exist where water in the subsurface is confined above by impermeable layers, and is best characterized by the bedrock aquifers that dip away from the Big Snowy Mountains and are overlain by impermeable shale's. By far, the most significant of these aquifers in the Big Springs Creek watershed is the Madison limestone. The Madison dips gently (8-10 degrees) away from the core of the Big Snowy Mountains and is topped by younger sandstones and shales, making it an ideal confined aquifer (Figure 2-13).

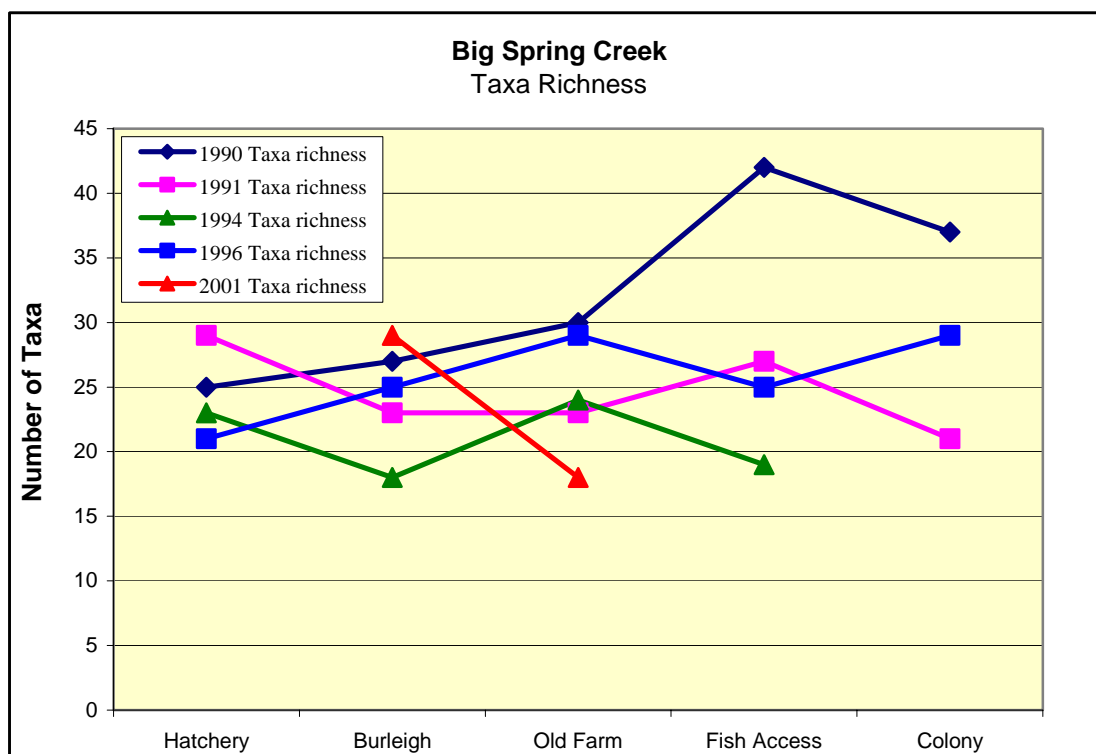
**Taxa Richness** (the number of unique taxa present in a sample) for five sites along Big Spring Creek is shown in Figure 2-14. Taxa Richness generally decreases with increasing degradation of riparian areas and water quality. However, slight increases in taxa richness can be observed where mild nutrient enrichment of previously nutrient-limited waters occurs. As waters become more enriched in nutrients downstream, more tolerant forms appear, elevating taxa richness. Wisseman (1990) documented an increase in chironomid midge richness (tolerant form) from 4 taxa near the hatchery to 20 taxa at the Hruska fishing access north of town, indicating diminished water quality. Since 1990, however, downstream taxa richness has decreased substantially from 1990 levels, perhaps suggesting an improving trend in water quality.

Figure 2-14. Big Spring Creek Taxa Richness Trends Since 1990.

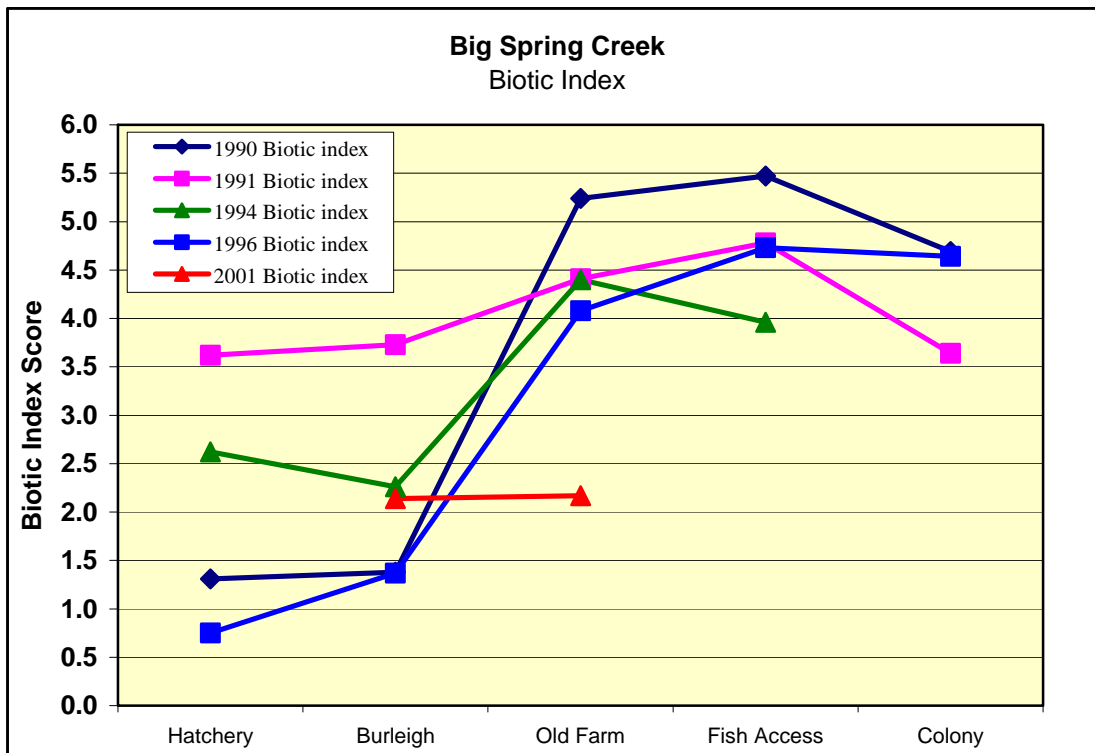
**Biotic Index** is an indicator of nutrient enrichment, and is a modification of the Hilsenhoff Biotic Index. The lower the Biotic Index value, the less impacted the biologic assemblage. Analysis of Macroinvertebrates from Montana foothill prairie streams by Bollman (1998) showed correlation between biotic index and water temperature, substrate embeddedness and fine sediment. Generally, taxa tolerant to nutrient-enriched conditions are also tolerant to the aforementioned habitat conditions as well. Figure 2-15 shows Biotic Index values for sites along Big Spring Creek from 1990 to 2001. With the exception of the most recent sampling event (2001), data shows a marked increase in biotic index value downstream of Lewistown, indicating a change in substrate habitat and/or water quality conditions.

**Figure 2-15. Big Spring Creek Biotic Index Trend Since 1990.**

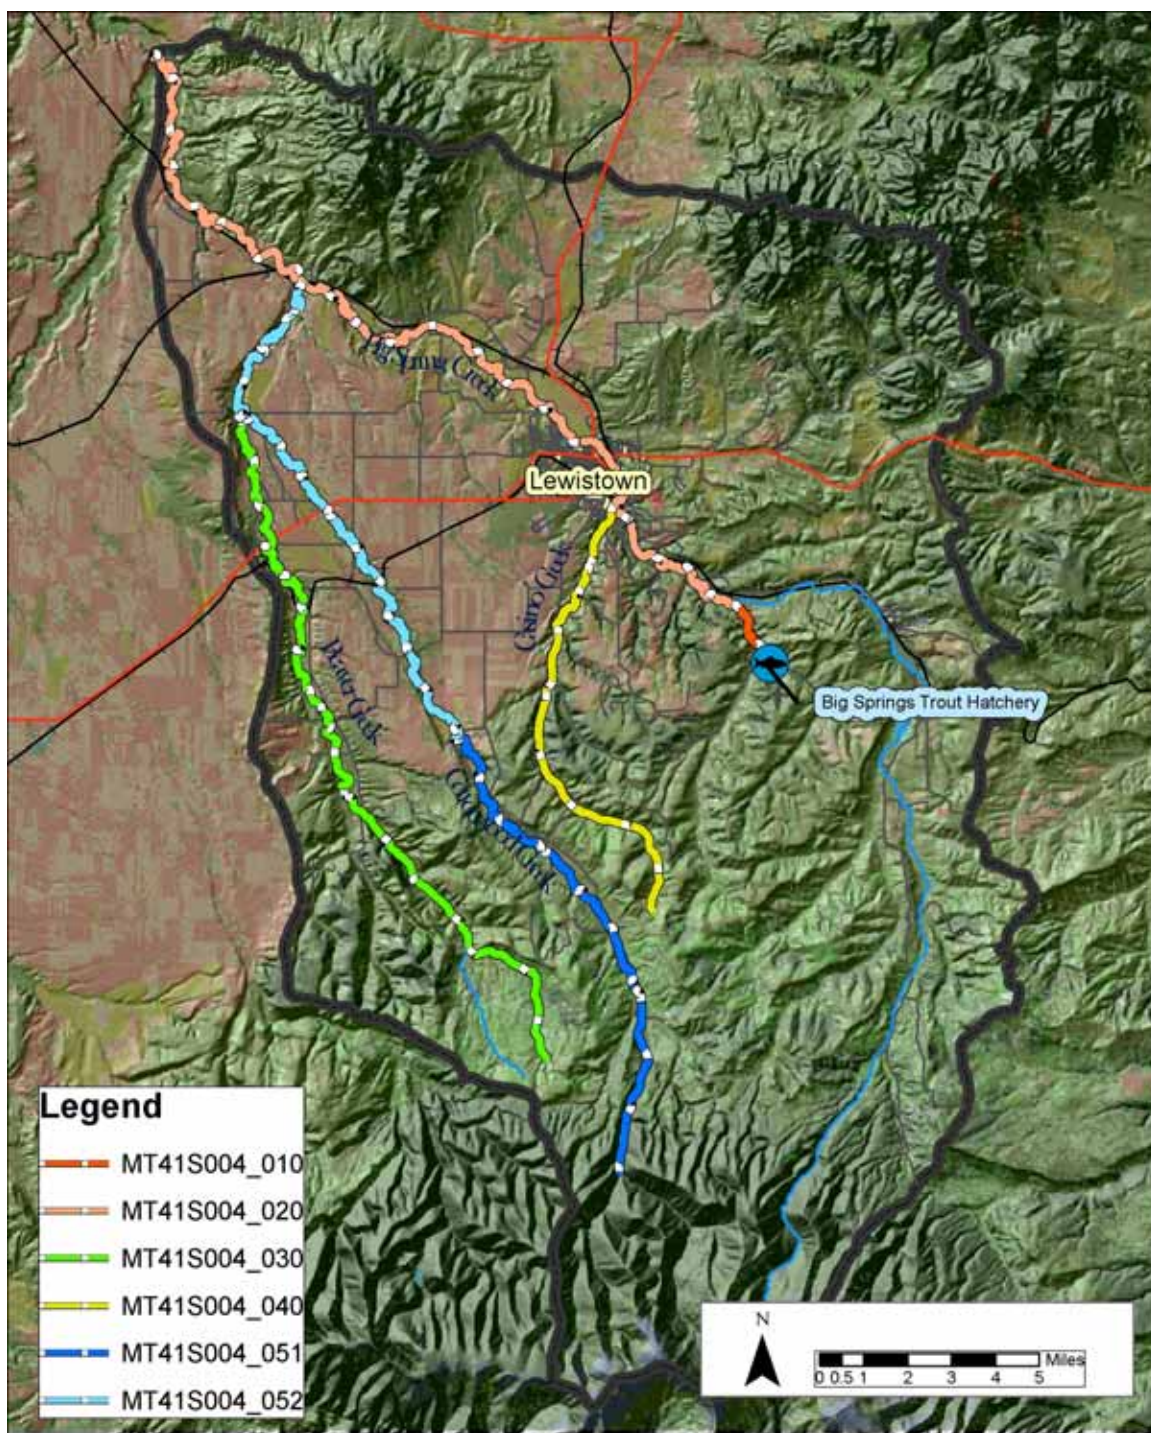
Figure 3-1. 303(d) Listed Waters in the Big Springs TMDL Planning Area.

Five waterbodies in the Big Spring Creek TMDL Planning Area occur on the Montana's 1996 303(d) list: Big Spring Creek (headwaters to East Fork), Big Spring Creek (East Fork to mouth), Beaver Creek, Casino Creek, and Cottonwood Creek. The causes and sources of impairment for each 1996 listing are indicated in Table 3-2 and the locations of the waters are shown in Figure 3-1.

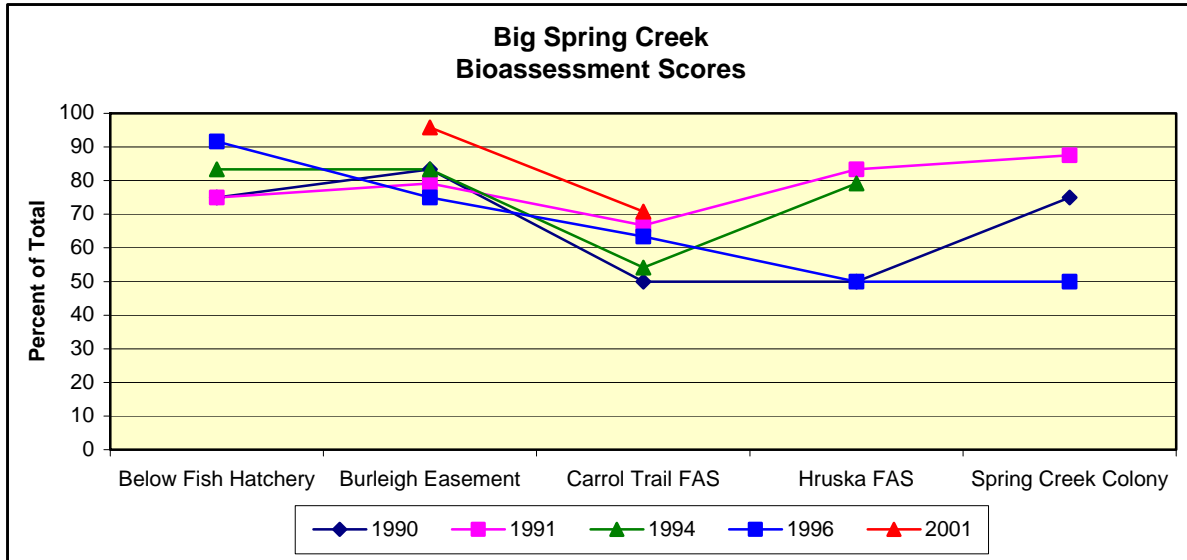
**Figure 4-2. Big Spring Creek Macroinvertebrate Bioassessment Scores (1990-2001).**

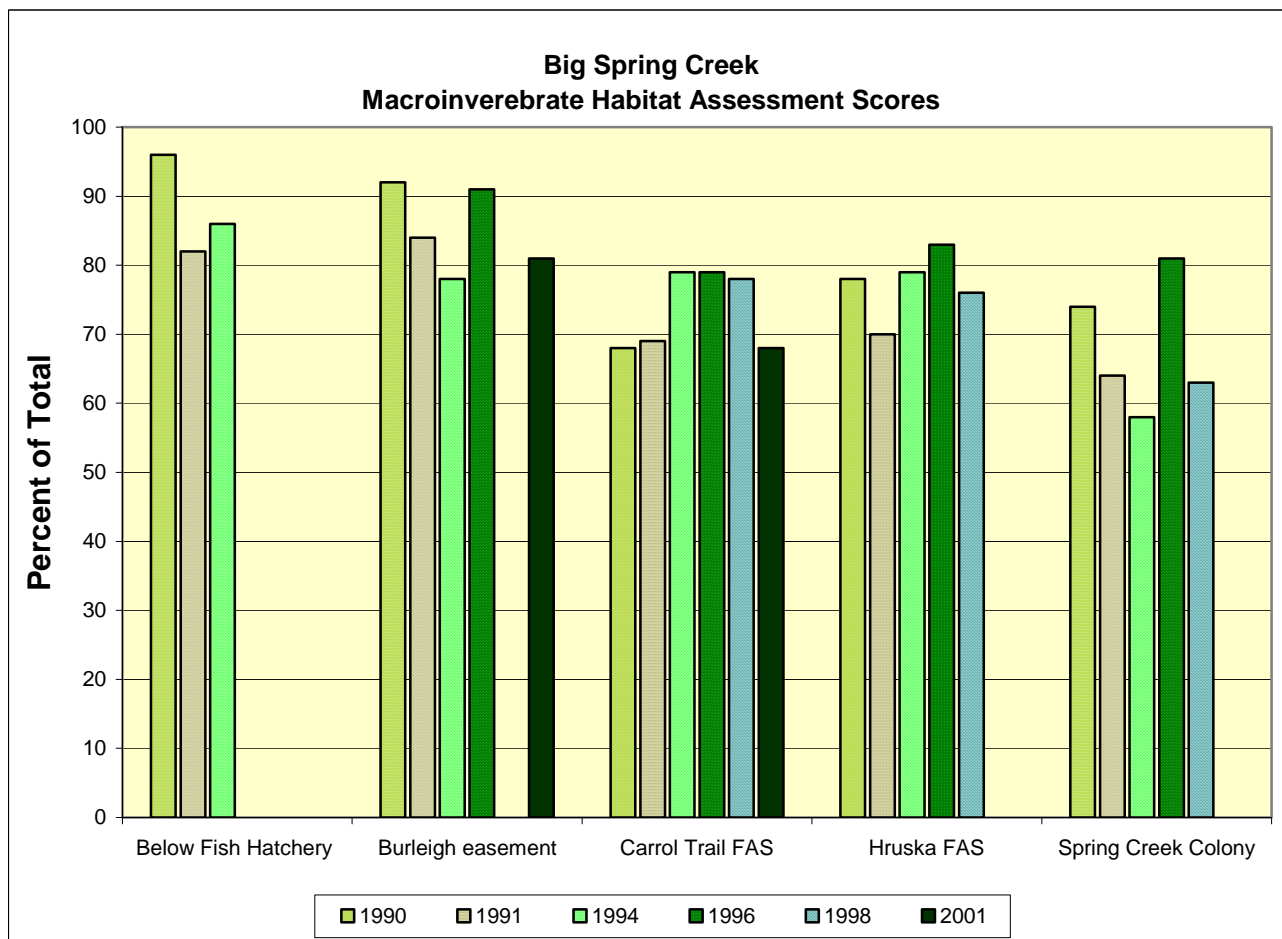
At the **Burleigh Easement** site, the percentage of clinger taxa (49%) collected in 2001 “suggests that benthic substrates were clean and unimpaired by fine sediment deposition” (Bollman, 2001). Likewise, “functional components of the benthic invertebrate community seem to be well balanced, with adequate representation of grazers, scrapers, predators, and shredders” (Bollman, 2001). EPT taxa richness was high (13) as was trichoptera richness (5). Multimetric bioassessment scores (Wisseman, 1992b) indicated unimpaired conditions (Figure 4-2). Macroinvertebrate habitat assessments scored in the optimal range in five of six years (Figure 4-3).

**Figure 4-3. Big Spring Creek Macroinvertebrate Habitat Assessment Scores (1990-2001).**

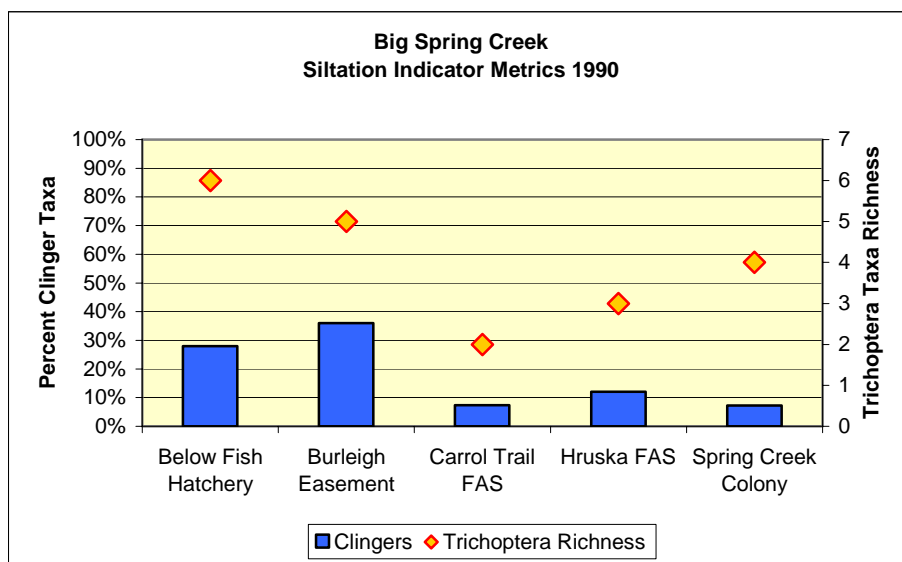
**Figure 4-4. Big Spring Creek Siltation Indicators 1990.**

Bioassessment scores below Lewistown (Carroll Trail FAS, Hruska FAS) indicate a decrease in biological integrity. Further downstream at the Spring Creek Colony site, bioassessment scores improve slightly. Compared to upstream sites, EPT Richness, percent clinger taxa and trichoptera richness all decrease at downstream sites implying degradation of water quality at both the Carroll Trail FAS and the Hruska FAS (Figures 4-4 thru 4-6). Also, specific reductions in the number of mayfly and stonefly taxa from sites upstream of Lewistown to sites downstream of Lewistown suggest reach-scale disturbances affect both Carroll Trail FAS and Hruska FAS (Bollman, 2001).

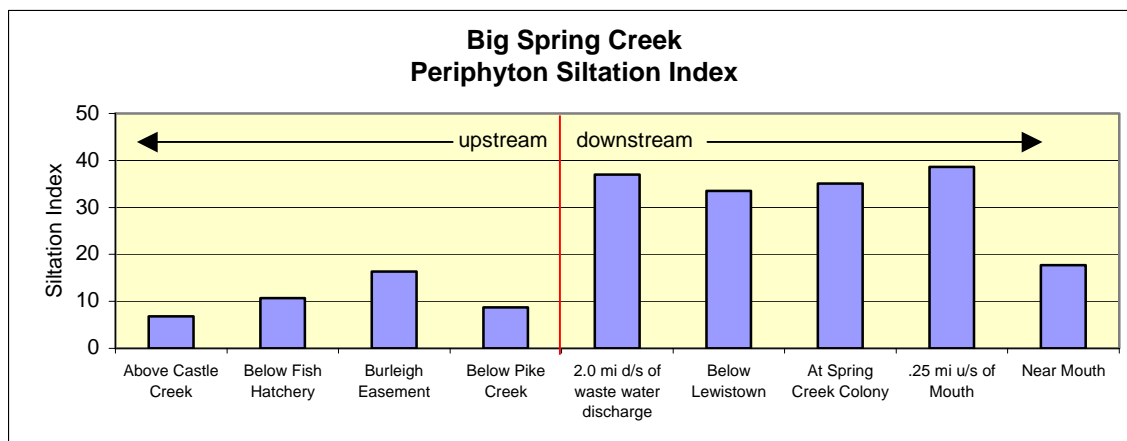
**Figure 4-7. Big Spring Creek Siltation Indices at Selected Sites.**

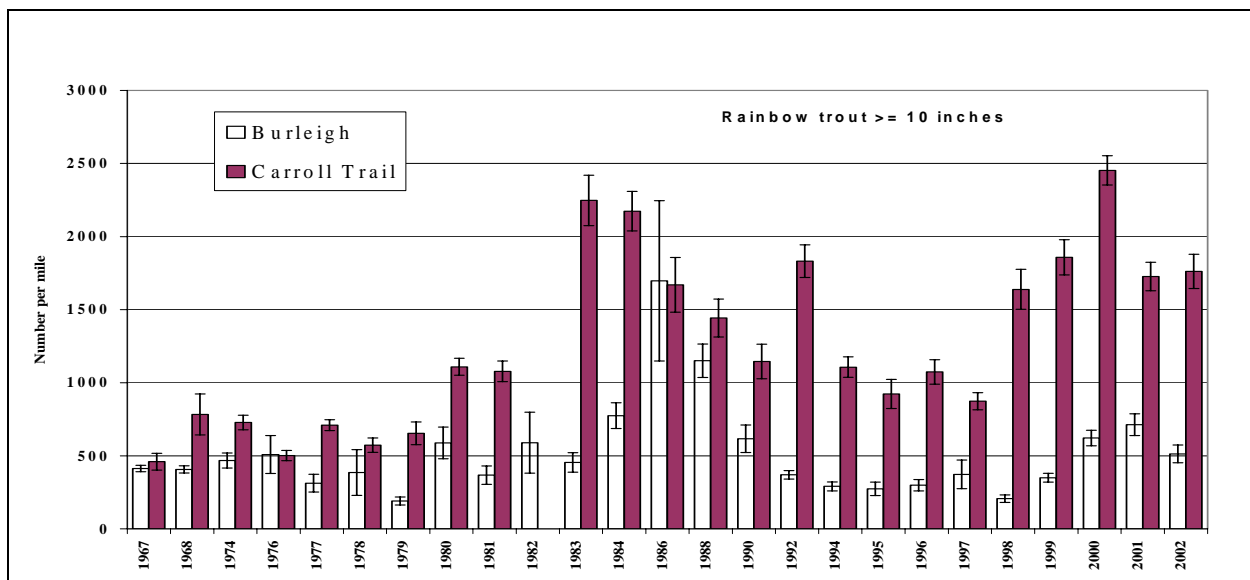
**Figure 4-10. Rainbow Trout (>10'') Densities at Burleigh Easement and Carroll Trail (1967-2002).**

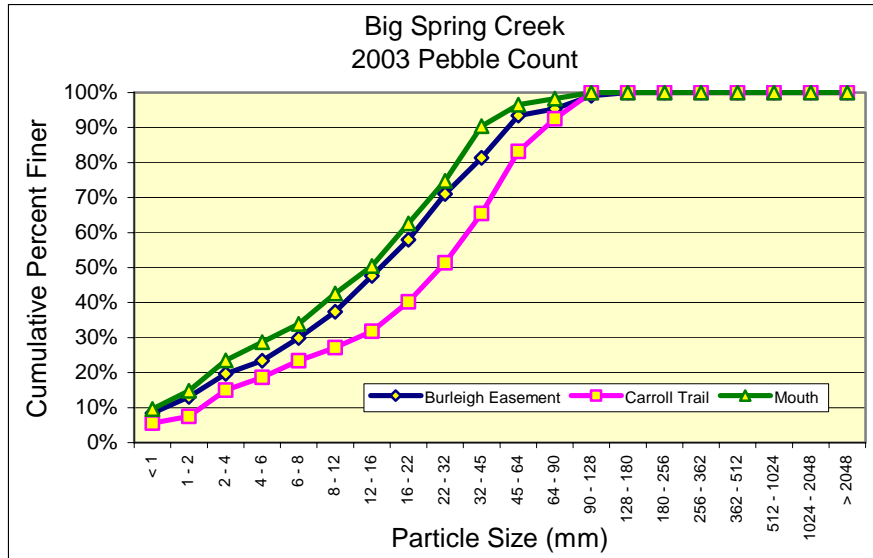
**Figure 4-12. Big Spring Creek 2003 Pebble Count.**

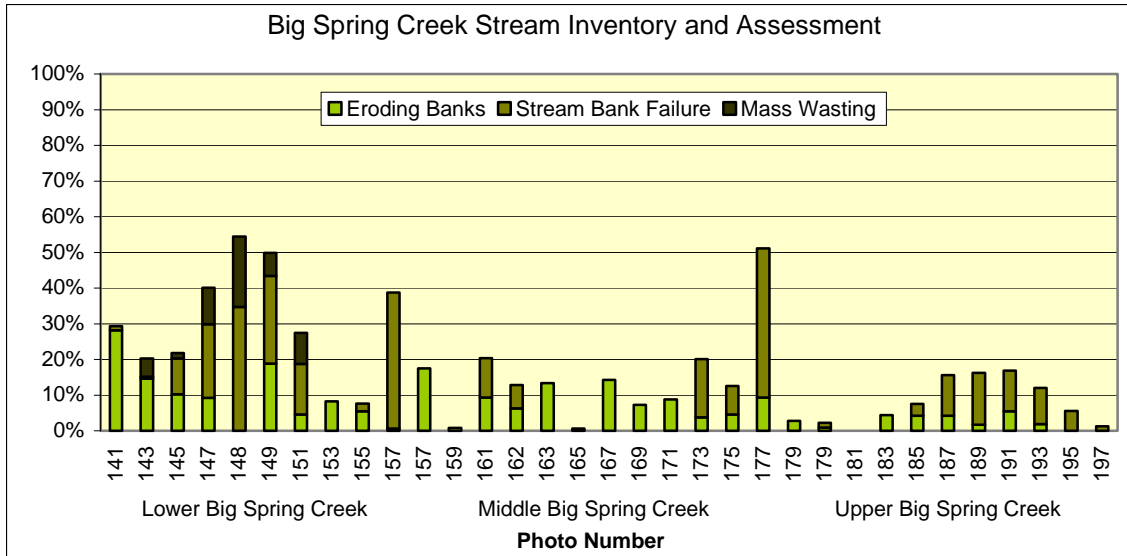
Overall, eroding banks and stream bank failure both increase in a downstream direction. While bank erosion and stream bank failure do not appear to be excessive on average, specific segments do exhibit erosion and failure levels much higher than the average (Figure 4-13). The majority of riprapped stream banks occur just above, through and below Lewistown (Figure 4-14). Mass Wasting occurs predominantly in the lower portion of Big Spring Creek (Figure 4-13).

**Figure 4-13. Stream Bank Condition by Reach (Modified from Hawn, et al., 1990).**

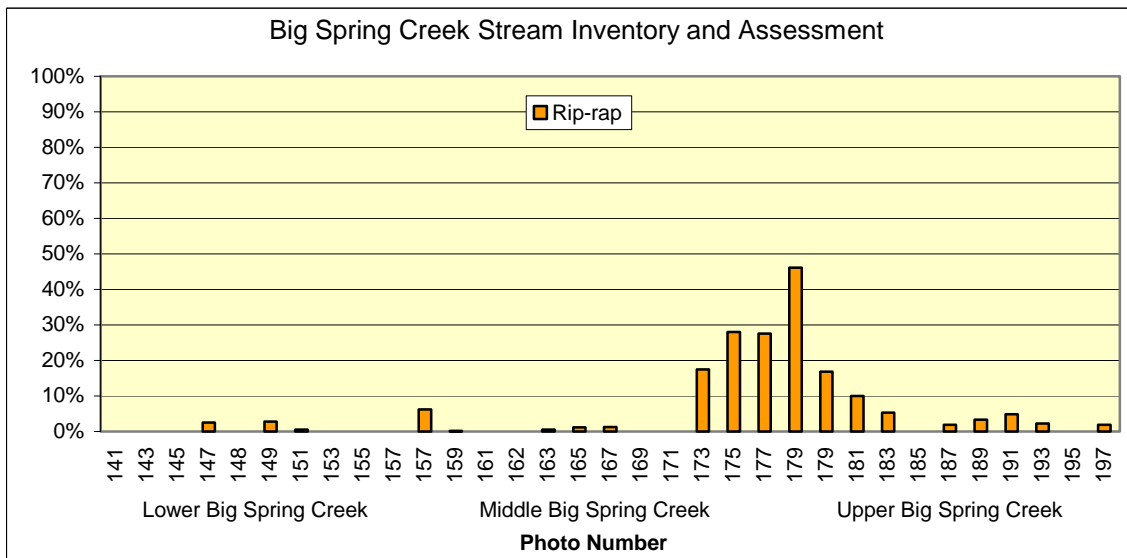
**Figure 4-14. Riprap by Reach (Modified from Hawn, et al., 1990).**

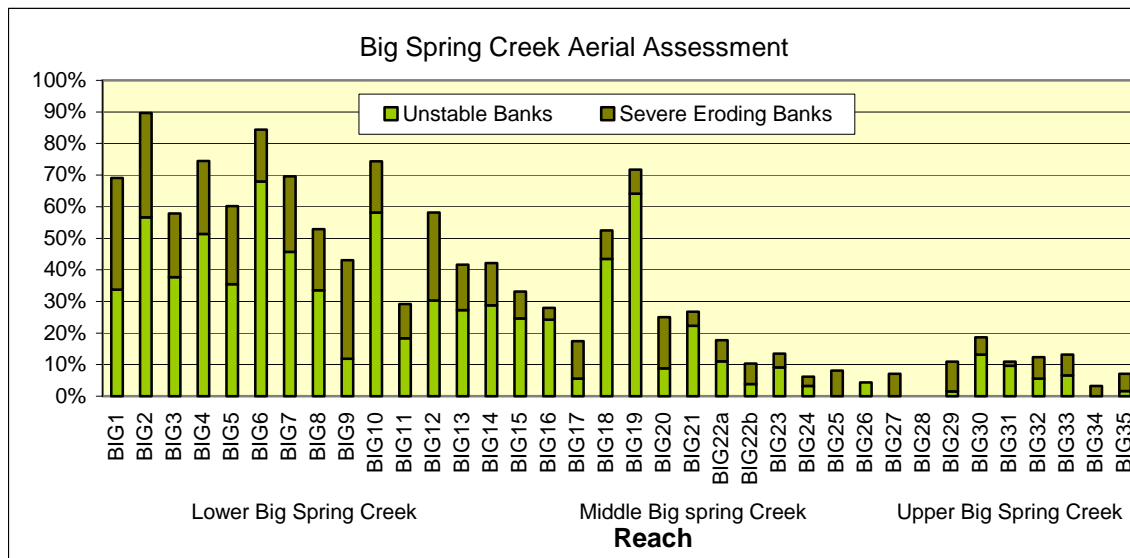
In general, bank erosion and bank instability increase in the downstream direction (Figure 4-15). Big Spring Creek upstream from Lewistown (Big28-Big35) exhibits low levels of bank instability and bank erosion. Bank instability and erosion levels increase noticeably downstream from Big20, just upstream from the Hruska Fishing Access Site. Channel riprap levels (Figure 4-16) are similar to those identified by Hawn in the 1990 Stream Inventory and Assessment.

**Figure 4-15. Big Spring Creek Channel Condition (Modified from Land & Water Consulting, 2003).**

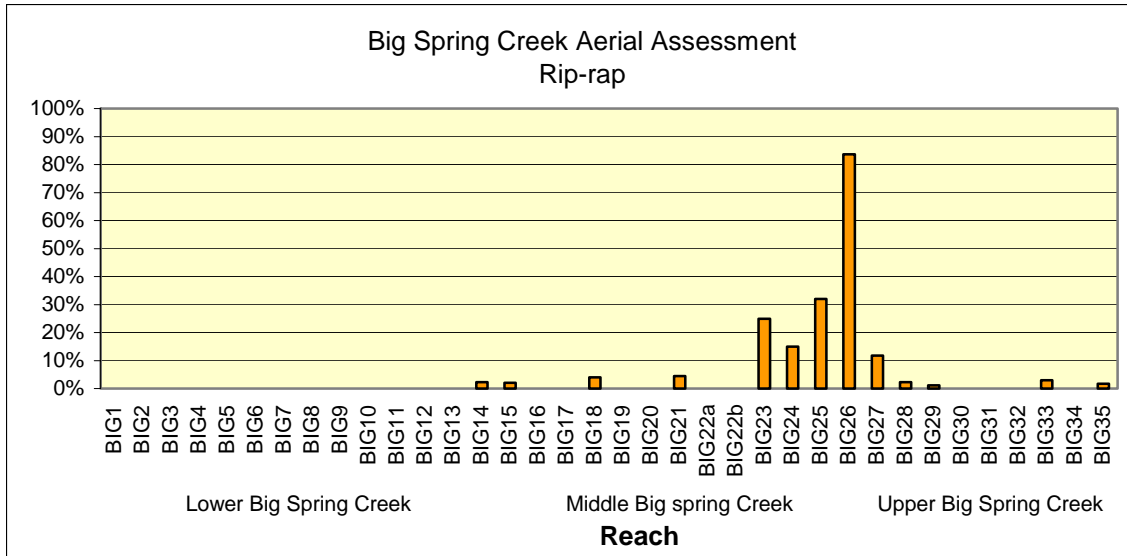
**Figure 4-16. Big Spring Creek Channel Riprap (Modified from Land & Water Consulting, 2003).**

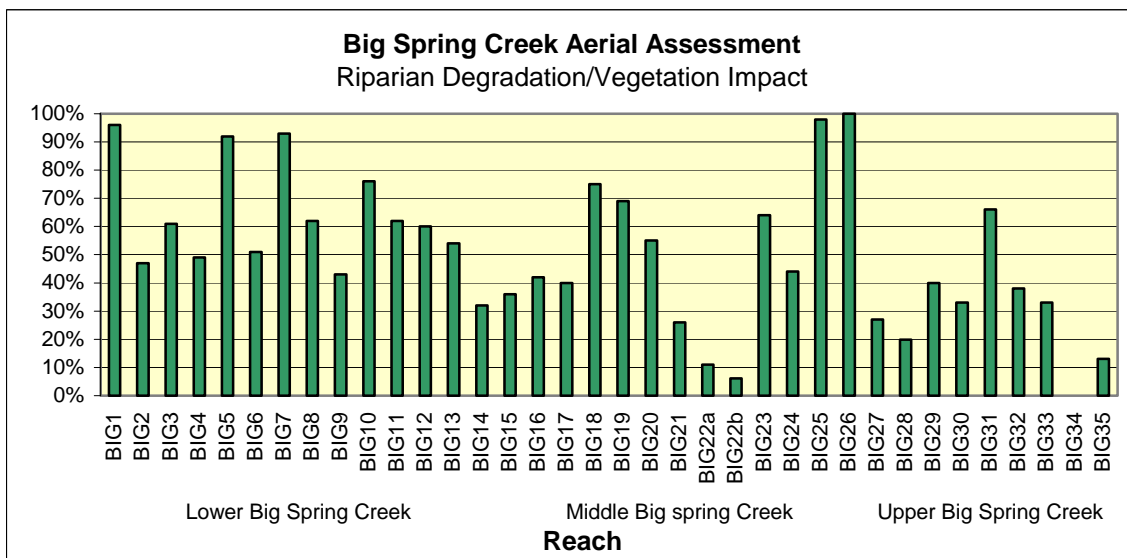
Paralleling channel condition, riparian degradation generally increases in a downstream direction (Figure 4-17). Riparian composition along upper and middle Big Spring Creek is characterized by a higher percentage of trees and woody shrubs than lower Big Spring Creek. Riparian composition along lower Big Spring Creek is predominantly grass/sedge communities (Figure 4-18).

**Figure 4-17. Big Spring Creek Degraded Riparian Vegetation (Modified from Land & Water Consulting, 2003).**

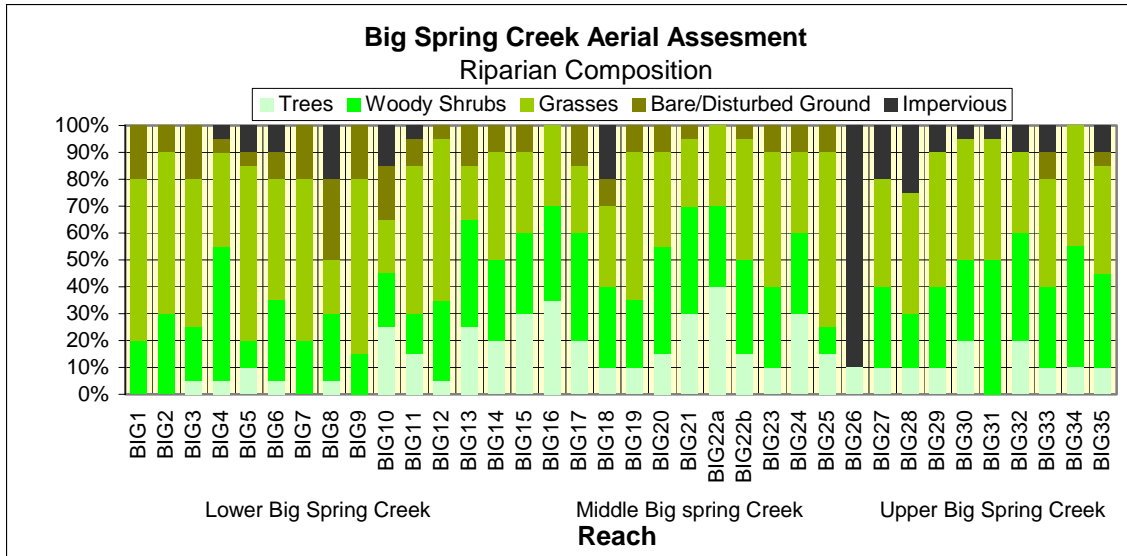
**Figure 4-18. Big Spring Creek Riparian Composition (Modified from Land & Water Consulting, 2003).**

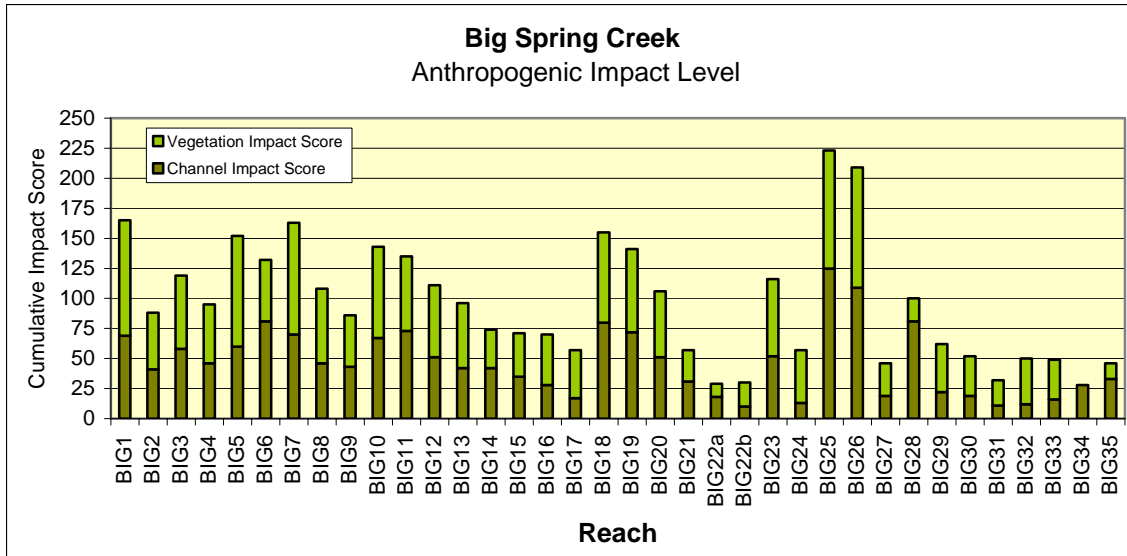
Information obtained on vegetation condition and channel condition was used to develop overall ratings named *Vegetation Impact Category* and *Channel Impact Category* (Appendix B). *Vegetation Impact Category* is a rating of *lightly impacted*, *moderately impacted* or *highly impacted*, and relies on the amount of degraded riparian vegetation determined from aerial assessment. *Channel Impact Category* is a rating of *lightly impacted*, *moderately impacted* or *highly impacted* based on the cumulative score of the percentages of riprap, channelization, unstable banks and severely eroding banks. A general rating of anthropogenic impact level that sums both vegetation impact and channel impact scores is given in Figure 4-19. Impact levels are rather low (generally below 50) upstream from Lewistown (Big26), providing support for low levels of biological impacts (Section 4.1.1.1). Relatively high impact levels for reaches Big25 and Big26 are present immediately upstream from Carroll Trail FAS (Big 24) and likely influence water quality conditions at Carroll Trail (high siltation index, low percent clingers, high surface fines).

**Figure 4-19. Big Spring Creek Anthropogenic Impact Level by Reach (Modified from Land & Water Consulting, 2003).**

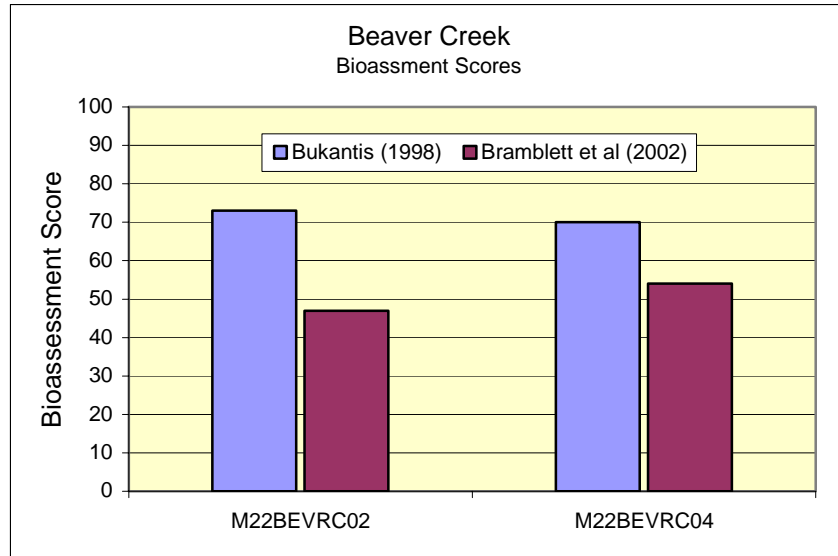
It is expected that sediment levels in plains streams are higher than in MVFP streams, and that macroinvertebrate assemblages reflect this natural change in substrate and habitat conditions. Consequently, it is expected that biotic assemblages downstream from M22BEVRC01 may reflect this environmental gradient. Beneficial use support at sites M22BEVRC02 and M22BEVRC04 was evaluated using both a Montana Plains ecoregion metric developed by Bukantis (1998), and another by Bramblett et al. (2002). Figure 4-21 shows Bioassessment scores based on these two metrics. While metric response varies, both metric scores are below 75%, indicating partial support of beneficial uses.

**Figure 4-21. Plains Bioassessment Scores for Two Sites on Beaver Creek.**

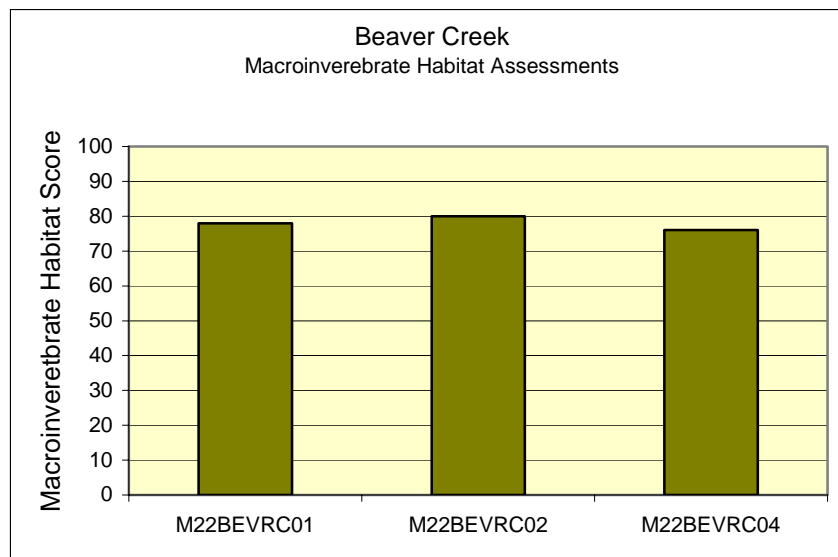
Macroinvertebrate habitat assessments were conducted at each sampling location on Beaver Creek (Figure 4-22).

**Figure 4-22. Beaver Creek Macroinvertebrate Habitat Assessment Scores (2003).**

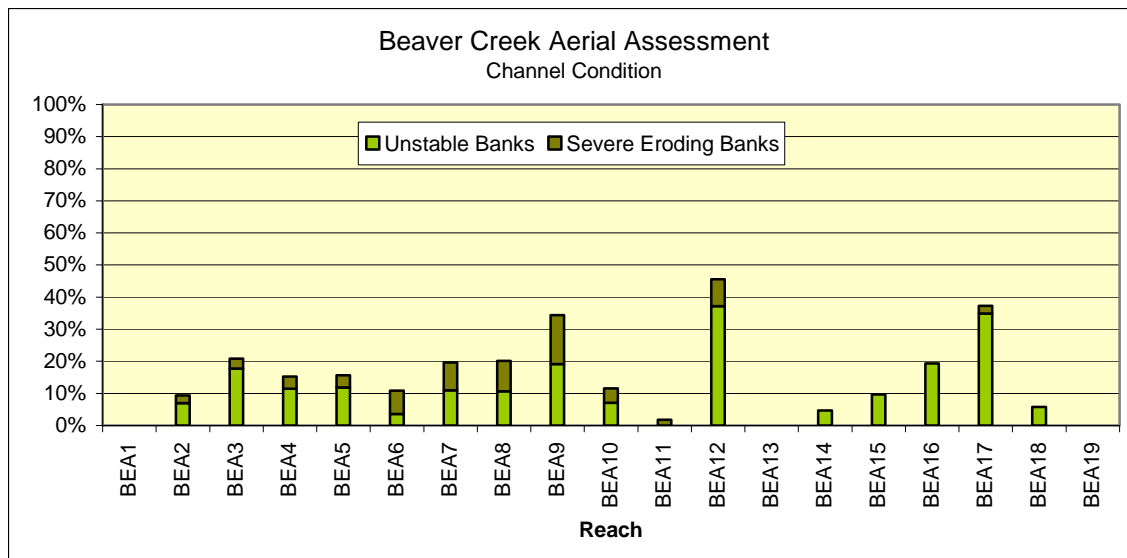
**Figure 4-25. Beaver Creek Channel Condition (Modified from Land & Water Consulting, 2003).**

Based on this assessment, combined bank erosion and bank instability are below 20% in all but 3 of 19 reaches. Several reaches had very low to negligible amounts of bank erosion. Riparian degradation ranged from 0% to 83% per reach with an average value of 41% for all of Beaver Creek. Riparian degradation, however, is not considered a cause of impairment in itself, nor does it necessarily correspond to higher levels of sediment input, especially in more stable E-channel systems. For instance, in the case of Beaver Creek, many reaches with a high percentage of riparian degradation also had relatively low levels of bank erosion and instability. Riparian vegetation composition is dominated by trees and woody shrubs and make up over 63% of the riparian cover on Beaver Creek. In many reaches, streamside vegetation is very lush, even though buffer zones may be limited. Figure 4-28 illustrates a typical segment of Beaver Creek. Note that even though riparian degradation is evident, there is very little bank erosion.

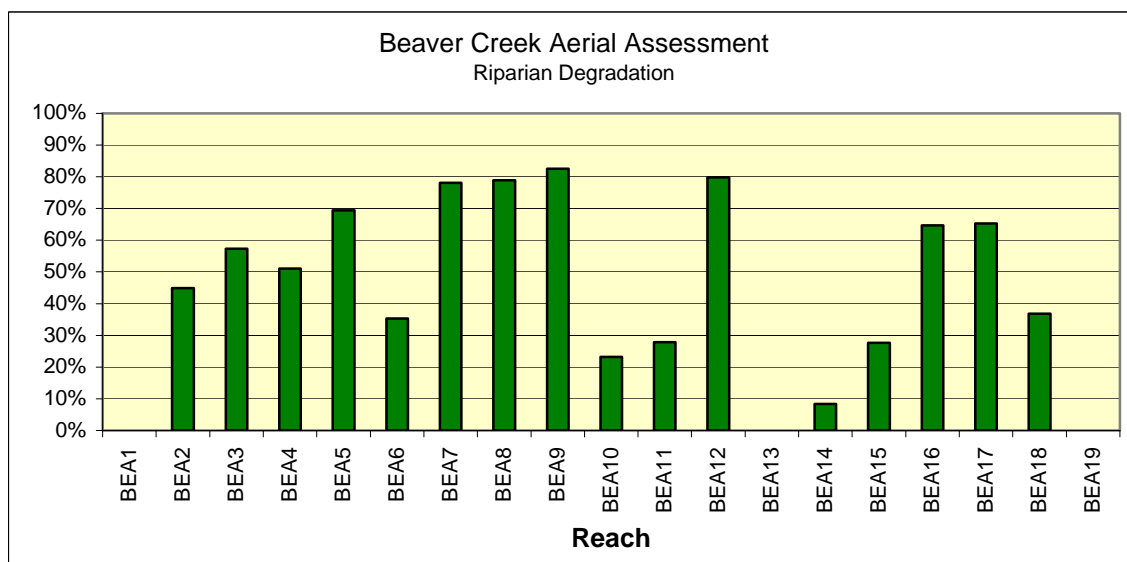
**Figure 4-26. Beaver Creek Degraded Riparian Vegetation (Modified from Land & Water Consulting, 2003)**

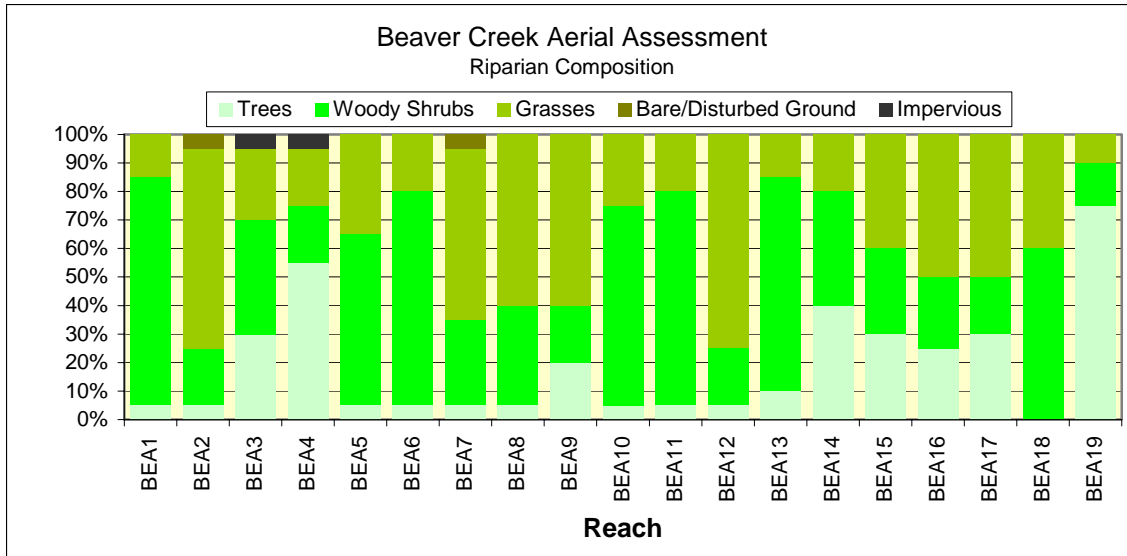
**Figure 4-27. Beaver Creek Riparian Composition (Modified from Land & Water Consulting, 2003).**

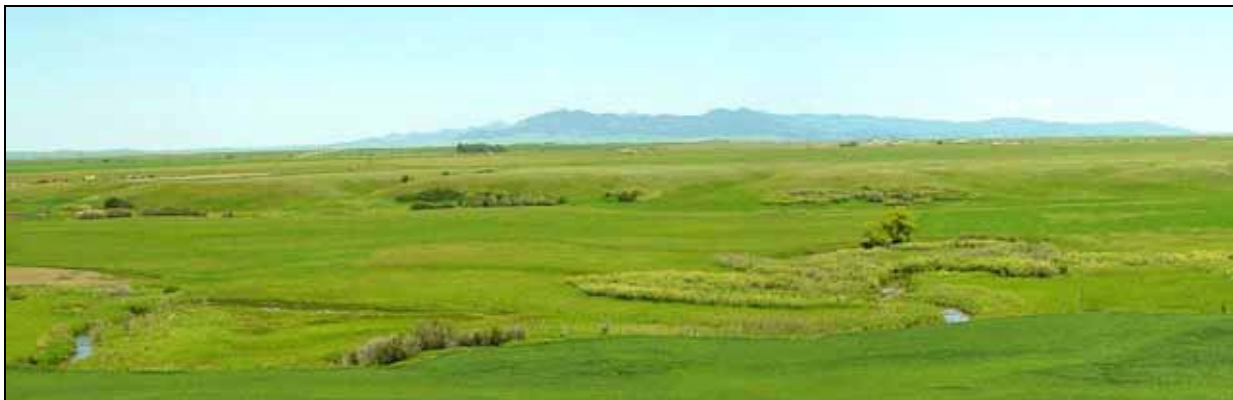
**Figure 4-28. Typical Riparian Condition of Beaver Creek (BEA5).**

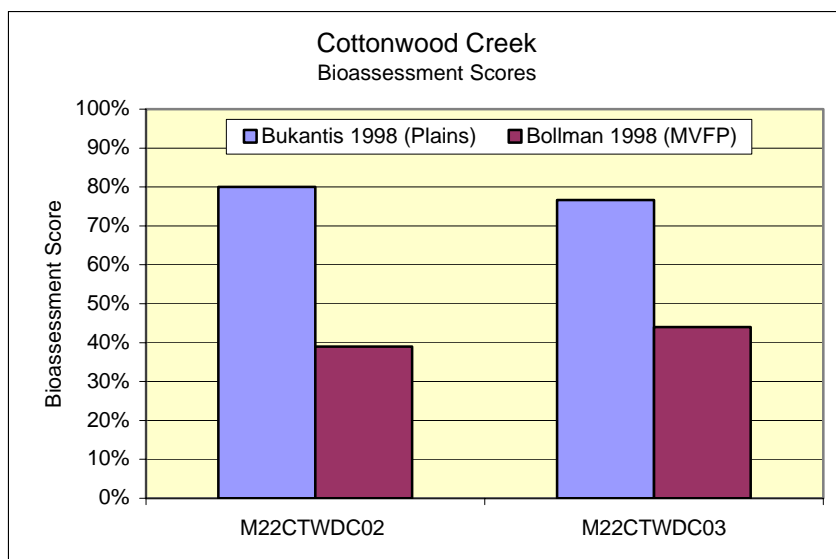
Beneficial use support at sites M22CTWDC02 and M22CTWDC03 was evaluated using both a Montana Plains ecoregion metric developed by Bukantis (1998), and the MVFP ecoregion metric developed by Bollman (1998). Figure 4-30 shows bioassessment scores based on these two metrics.

**Figure 4-30. Bioassessment Score Comparisons for Two Sites on Cottonwood Creek.**
